Arboricultural Impact Assessment

2 – 4 Riverpark Gardens, Bromley, BR2 0BG

Phoenix Community Housing

6th March 2015 Our Ref:DFCP3324 AIA (Rev B)

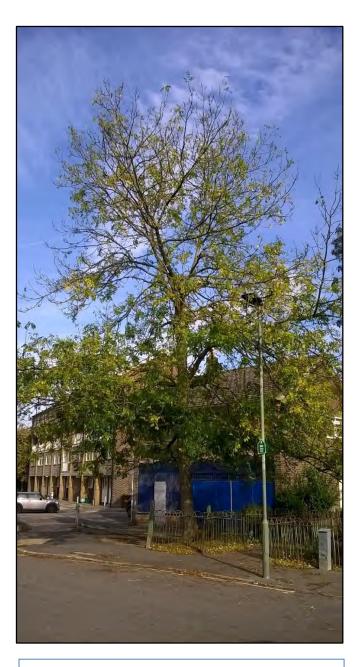
Image 1 (left).

From Ravensmead Road with T2 to the east of the existing derelict building.

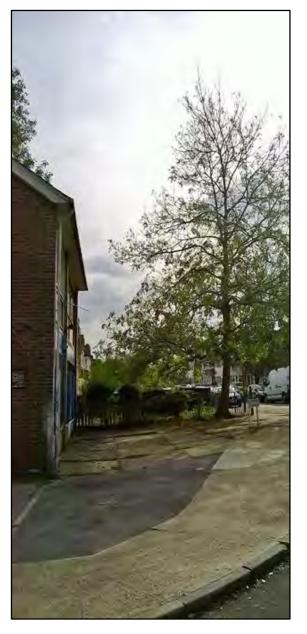
Image 2 (right).

T2 as seen looking south showing its close proximity to the dwelling proposed for demolition.

T2 is likely to need crown reducing to reduce the overall canopy size to facilitate the development as well as clear the head of the existing street light. All tree surgery works to facilitate the development and for obvious safety and arboricultural reasons can be found at Appendix 6.

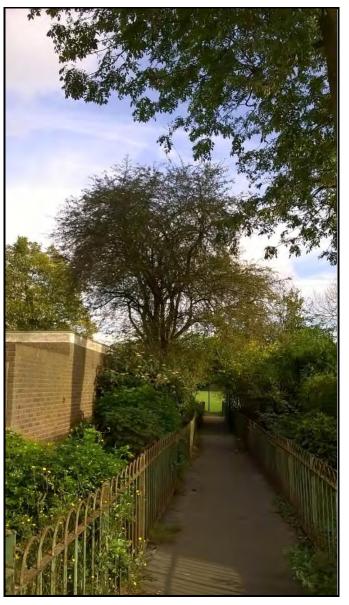
Image 3 (left).

T3 as seen from the public access to Warren Park with T1 on the right

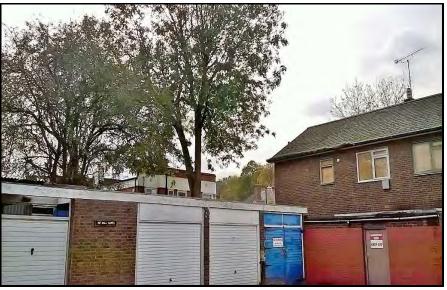
Image 4 (left).

From the interior of the footprint looking south with the subject trees T1 and T3 behind the garage block.

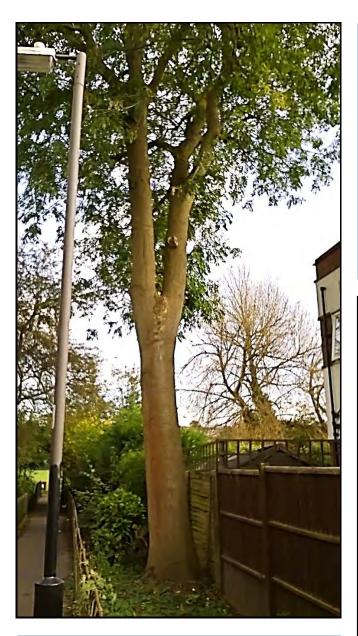
Image 4 (left).

Looking east towards Warren Avenue Playing Fields with T1 situated on the other side of the public access.

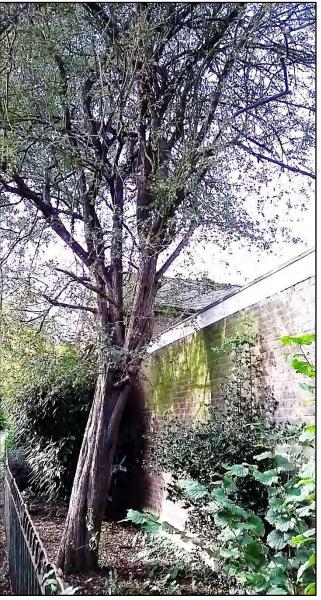
Image 5 (right).

T3 to the rear of the existing garage block looking from the public access to Warren Park.
