Arboricultural Report

BS5837 Tree Survey

**19 Ullswater Close
Bromley
BR1 4JF**

**Date
16th July 2015**

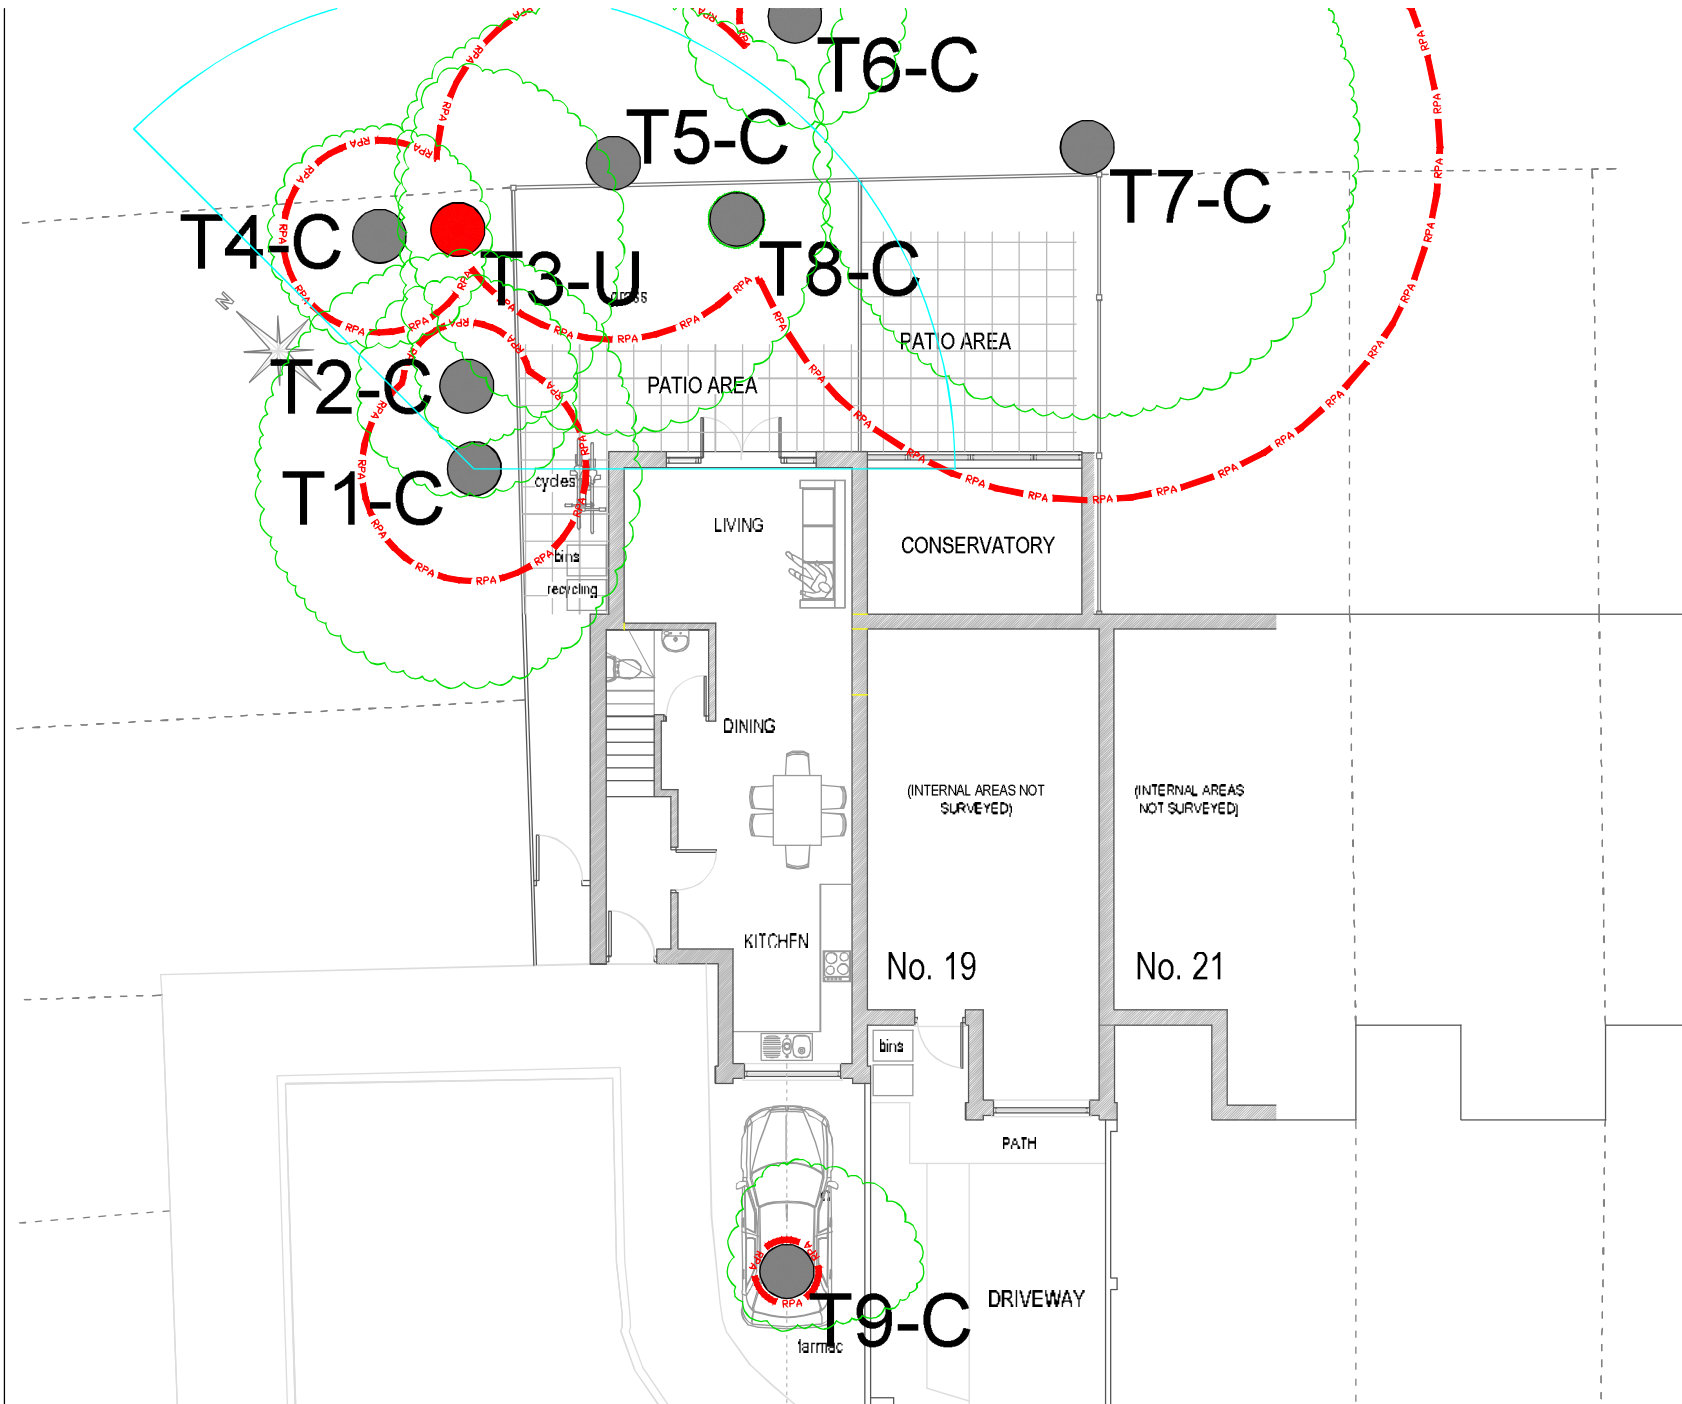
Dwg No **001**

TREE SURVEY & CONSTRAINTS PLAN

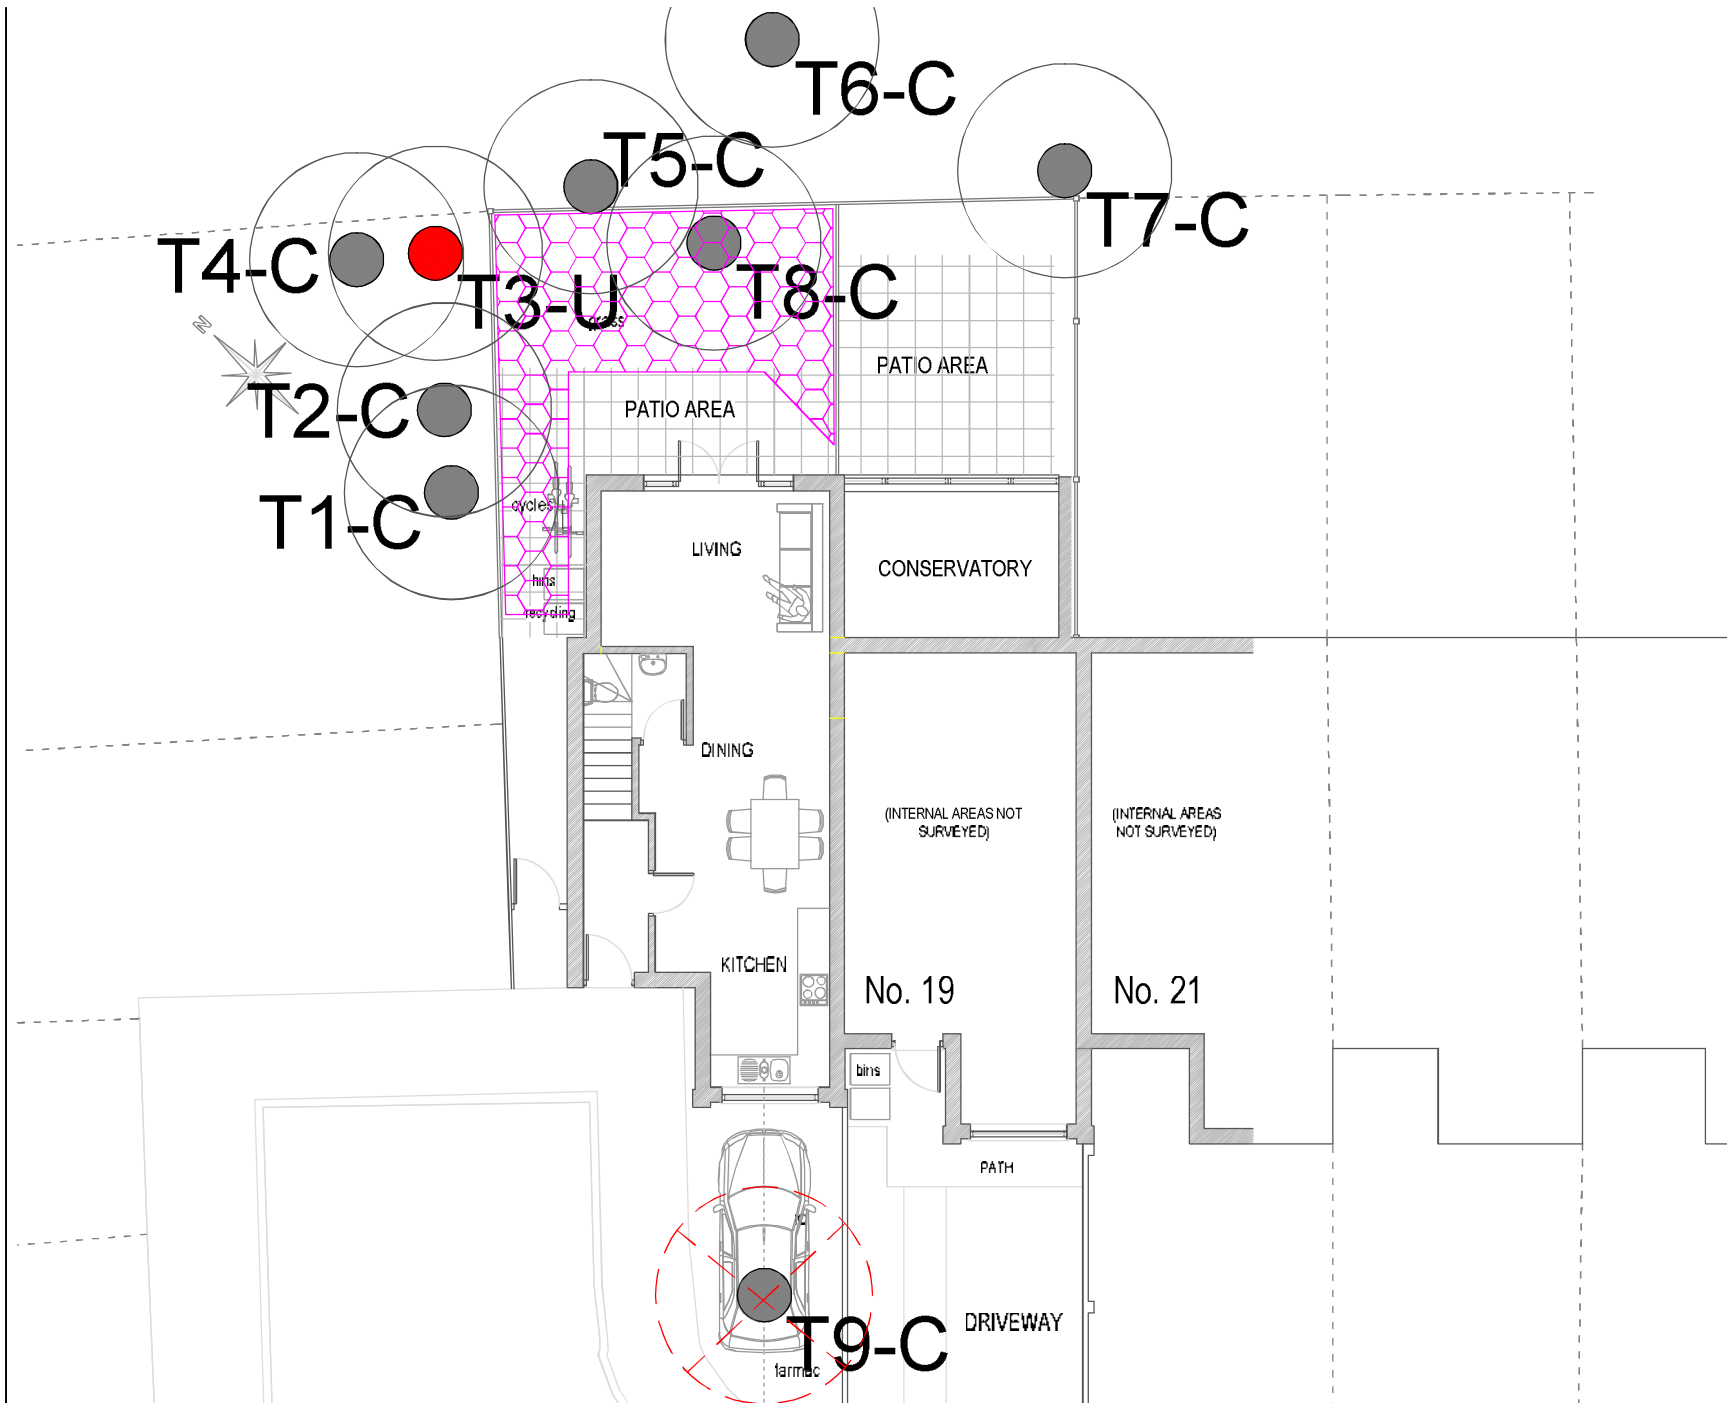
Dwg No **002**

Title **Draft Tree Protection Plan**
Job **19 Ullswater Close**
Scale **1:100 @ A3**
Date **16.07.2013**
Dwn **SB**
