Road Condition Report

Supporting pre commencement condition 11

Upfield, Hillbrow Road Bromley BR1 4JL

By North Star 2000 Ltd

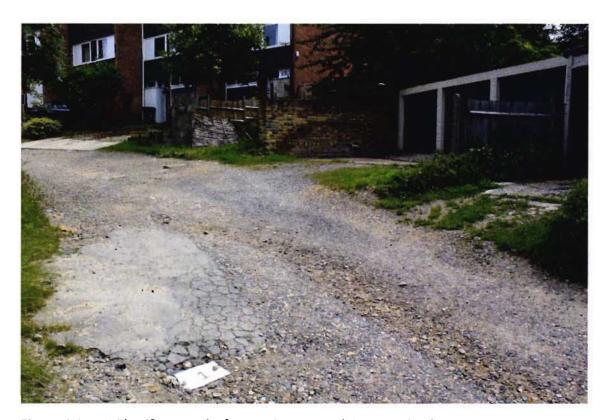
Picture 4: Item 1 identifies a patch of tarmac in poor condition opposite the garages.

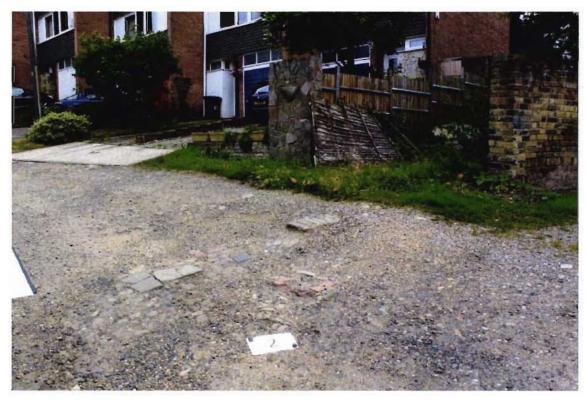
Picture 5: Item 2 Identifies broken brick work and uneven surfaces.

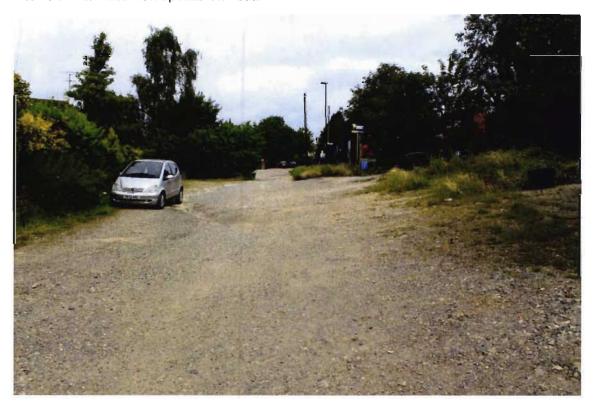
Picture 7: Some erosion shown beneath the car opposite Tresco Close.

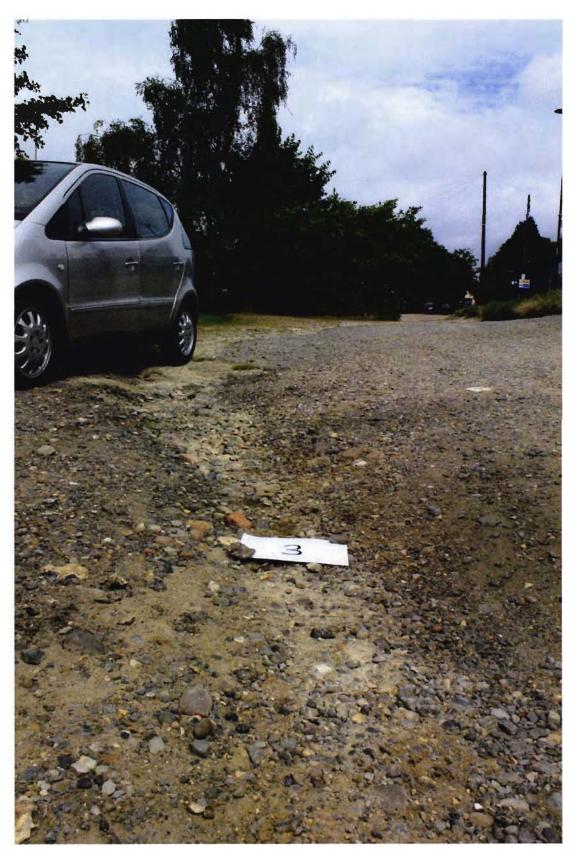
Picture 8: Item 3 shows erosion and an uneven road surface.

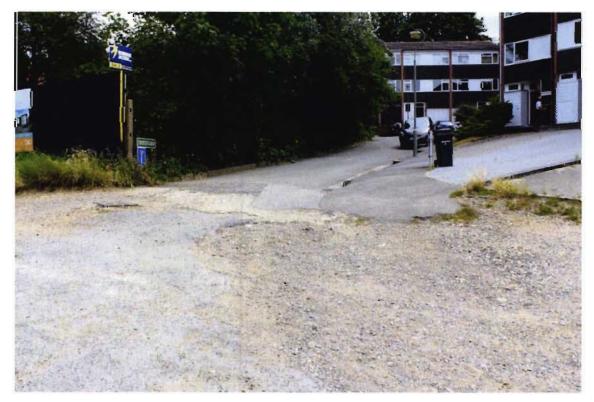
Picture 10: Shows the uneven road surface and mixed use of materials leading into Tresco Close.

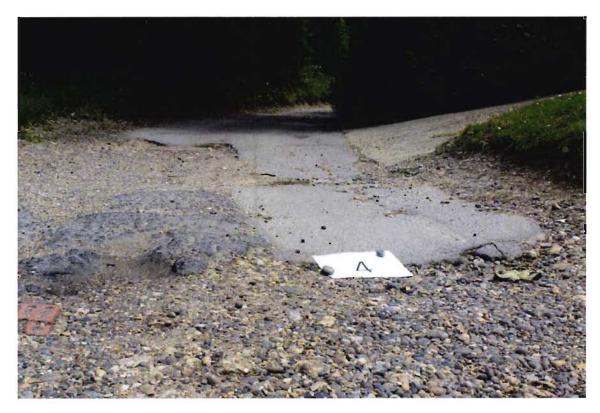
Picture 20: Item 4 Road surface in poor condition outside number 14.

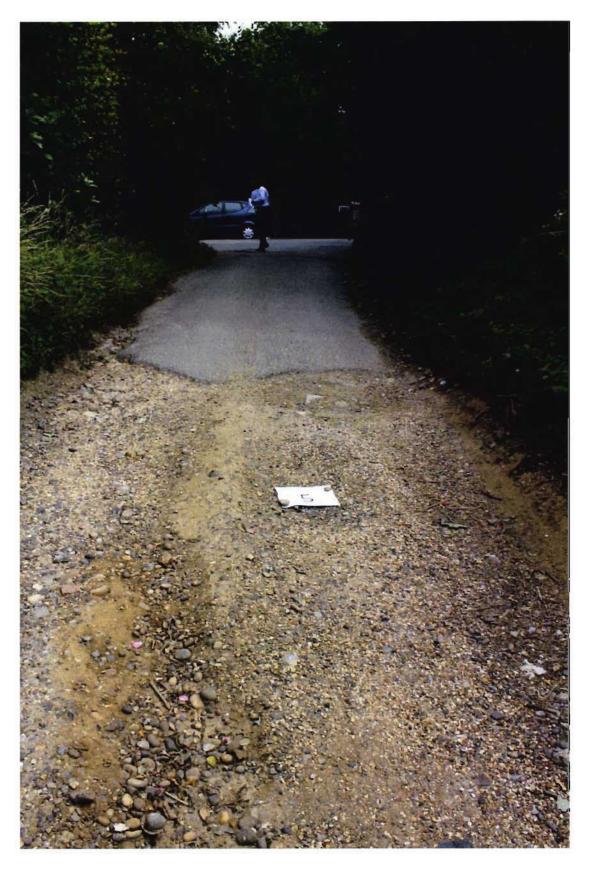
Picture 21: Item 5 Uneven road surface and potholes approaching Coniston Road.

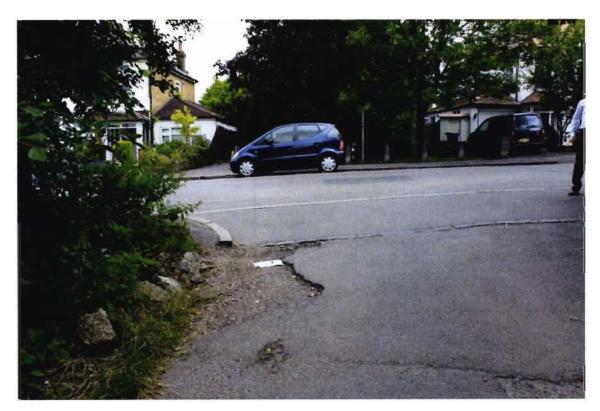
Picture 22: Item 6 Damaged Tarmac on the corner of Coniston Road / Hilbrow Road.

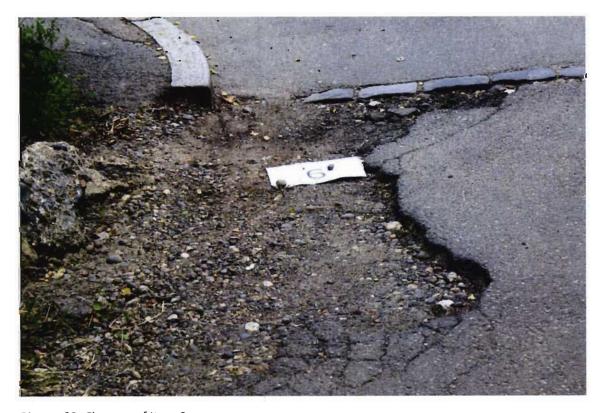
Picture 23: Close up of Item 6.
