**Arboricultural Report
(BS: 5837 2012)**

**Flat 39
20 Blythwood Park
Blyth Road
Bromley
Kent
BR1 3TN**

CLIENT:	Mr R Pooke
TREELINE REF:	26820
CONSULTANT:	Joseph Blackwell ND. Arb
REPORT DATE:	April 2015

**Pre-Development Tree Condition Survey
(BS: 5837 2012)**

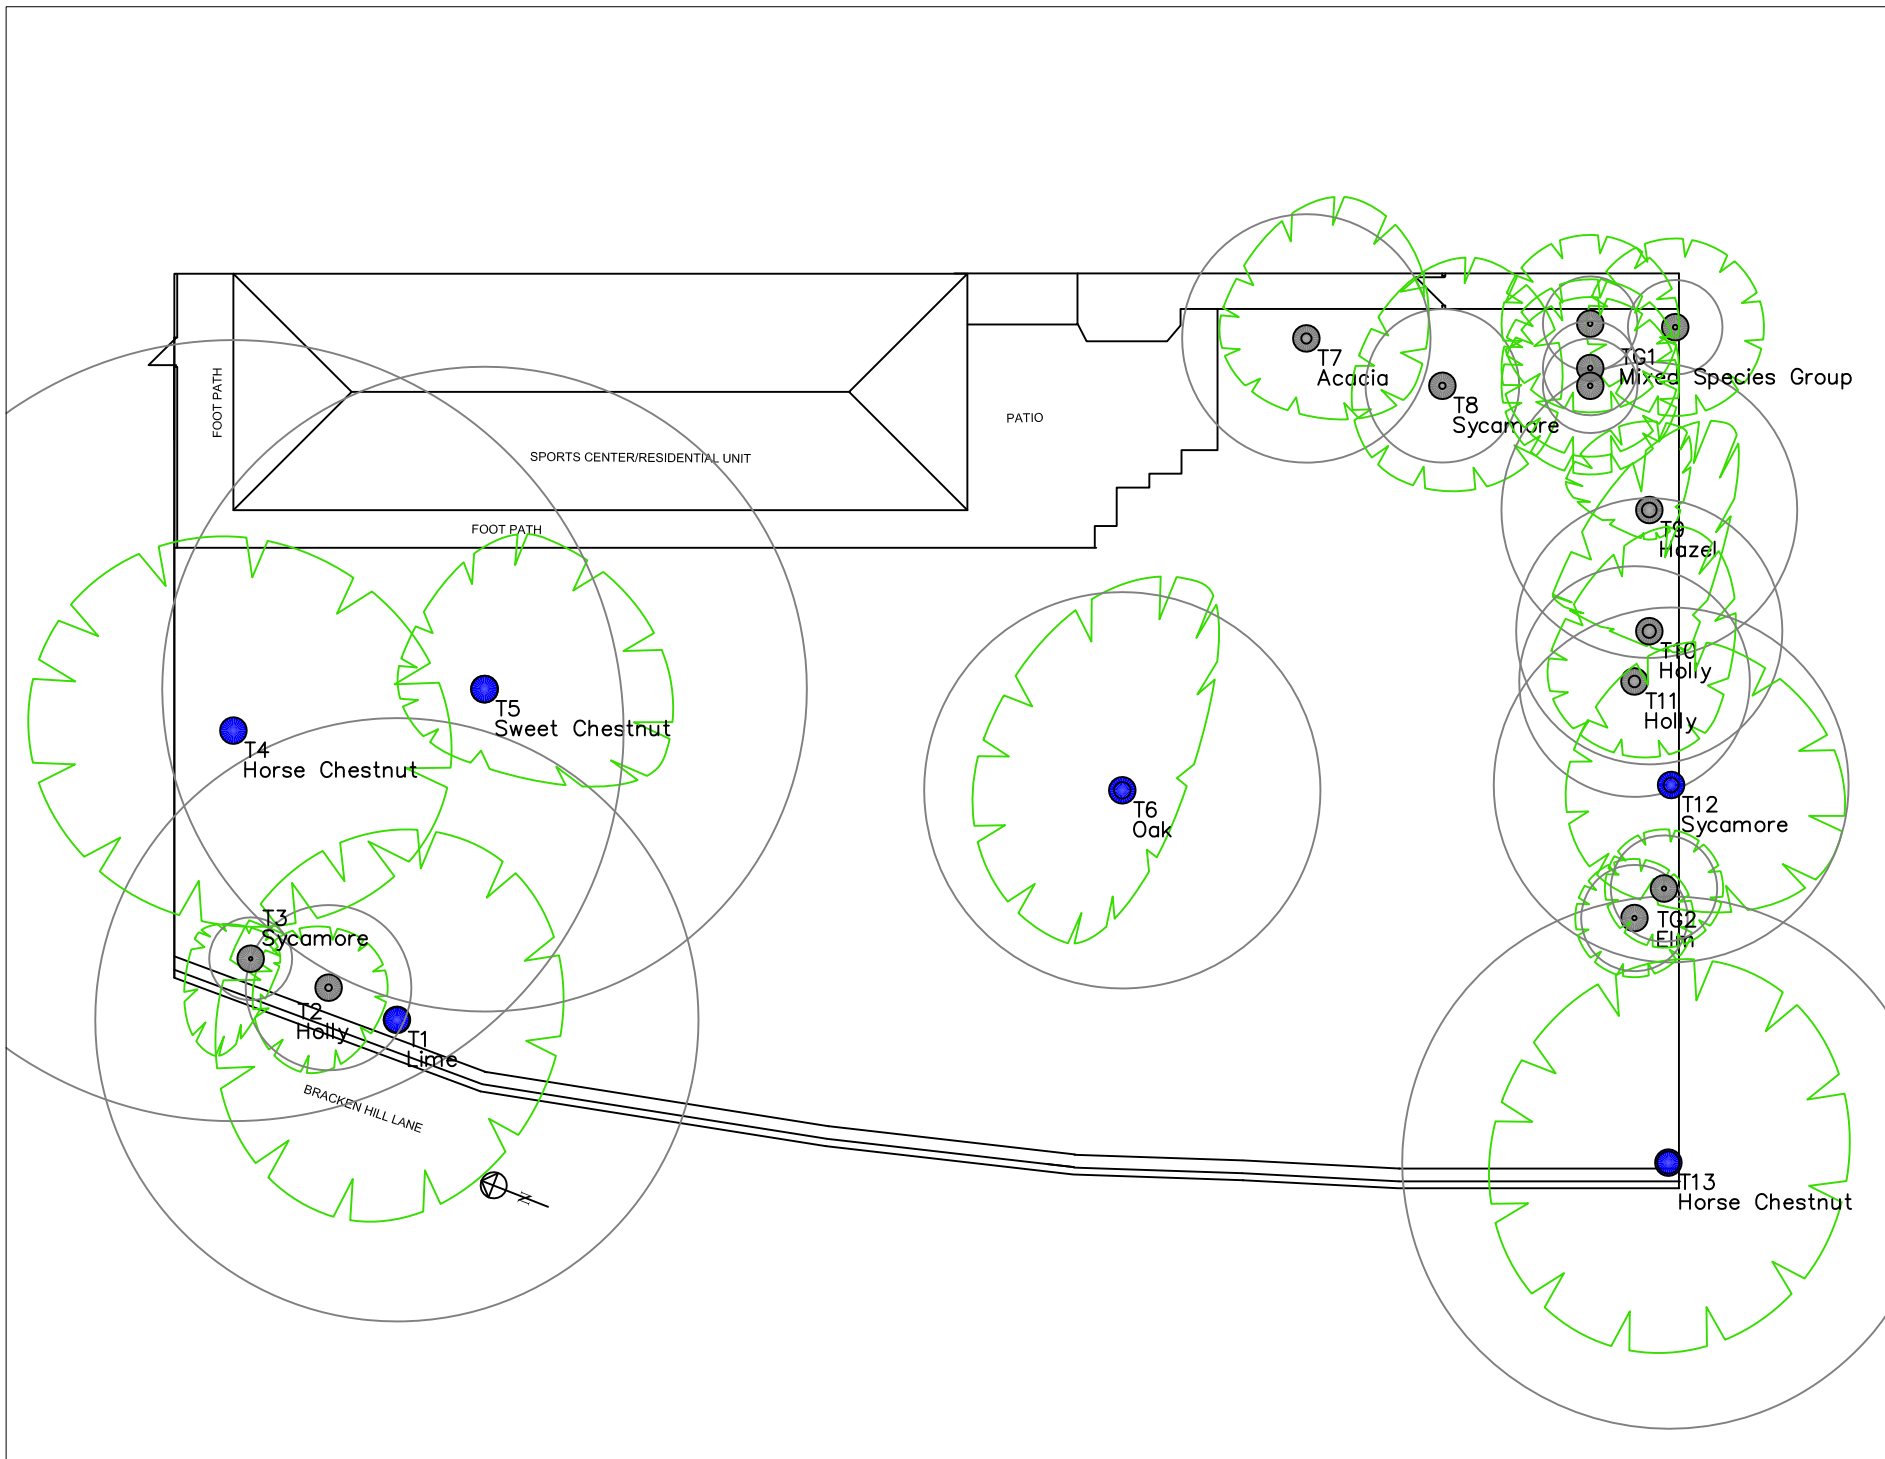
Tree Constraint Plan (TCP)

- 3.3 The tree stock was found to be low to high in quality and slightly varied in species, age, and size. The majority of trees surveyed were found to be located on or around the site boundaries with a minority located more central to the site. All of the trees surveyed are within the confines of the site and are under the ownership of Mr Pooke.

- 3.4 Overall the trees were found to be in average health and vigour at the time of inspection. A small number were found to have low vigour, indifferent or poor form, structural defects and decay. The most significant trees surveyed at the site were the larger mature trees nearest the northern extent.

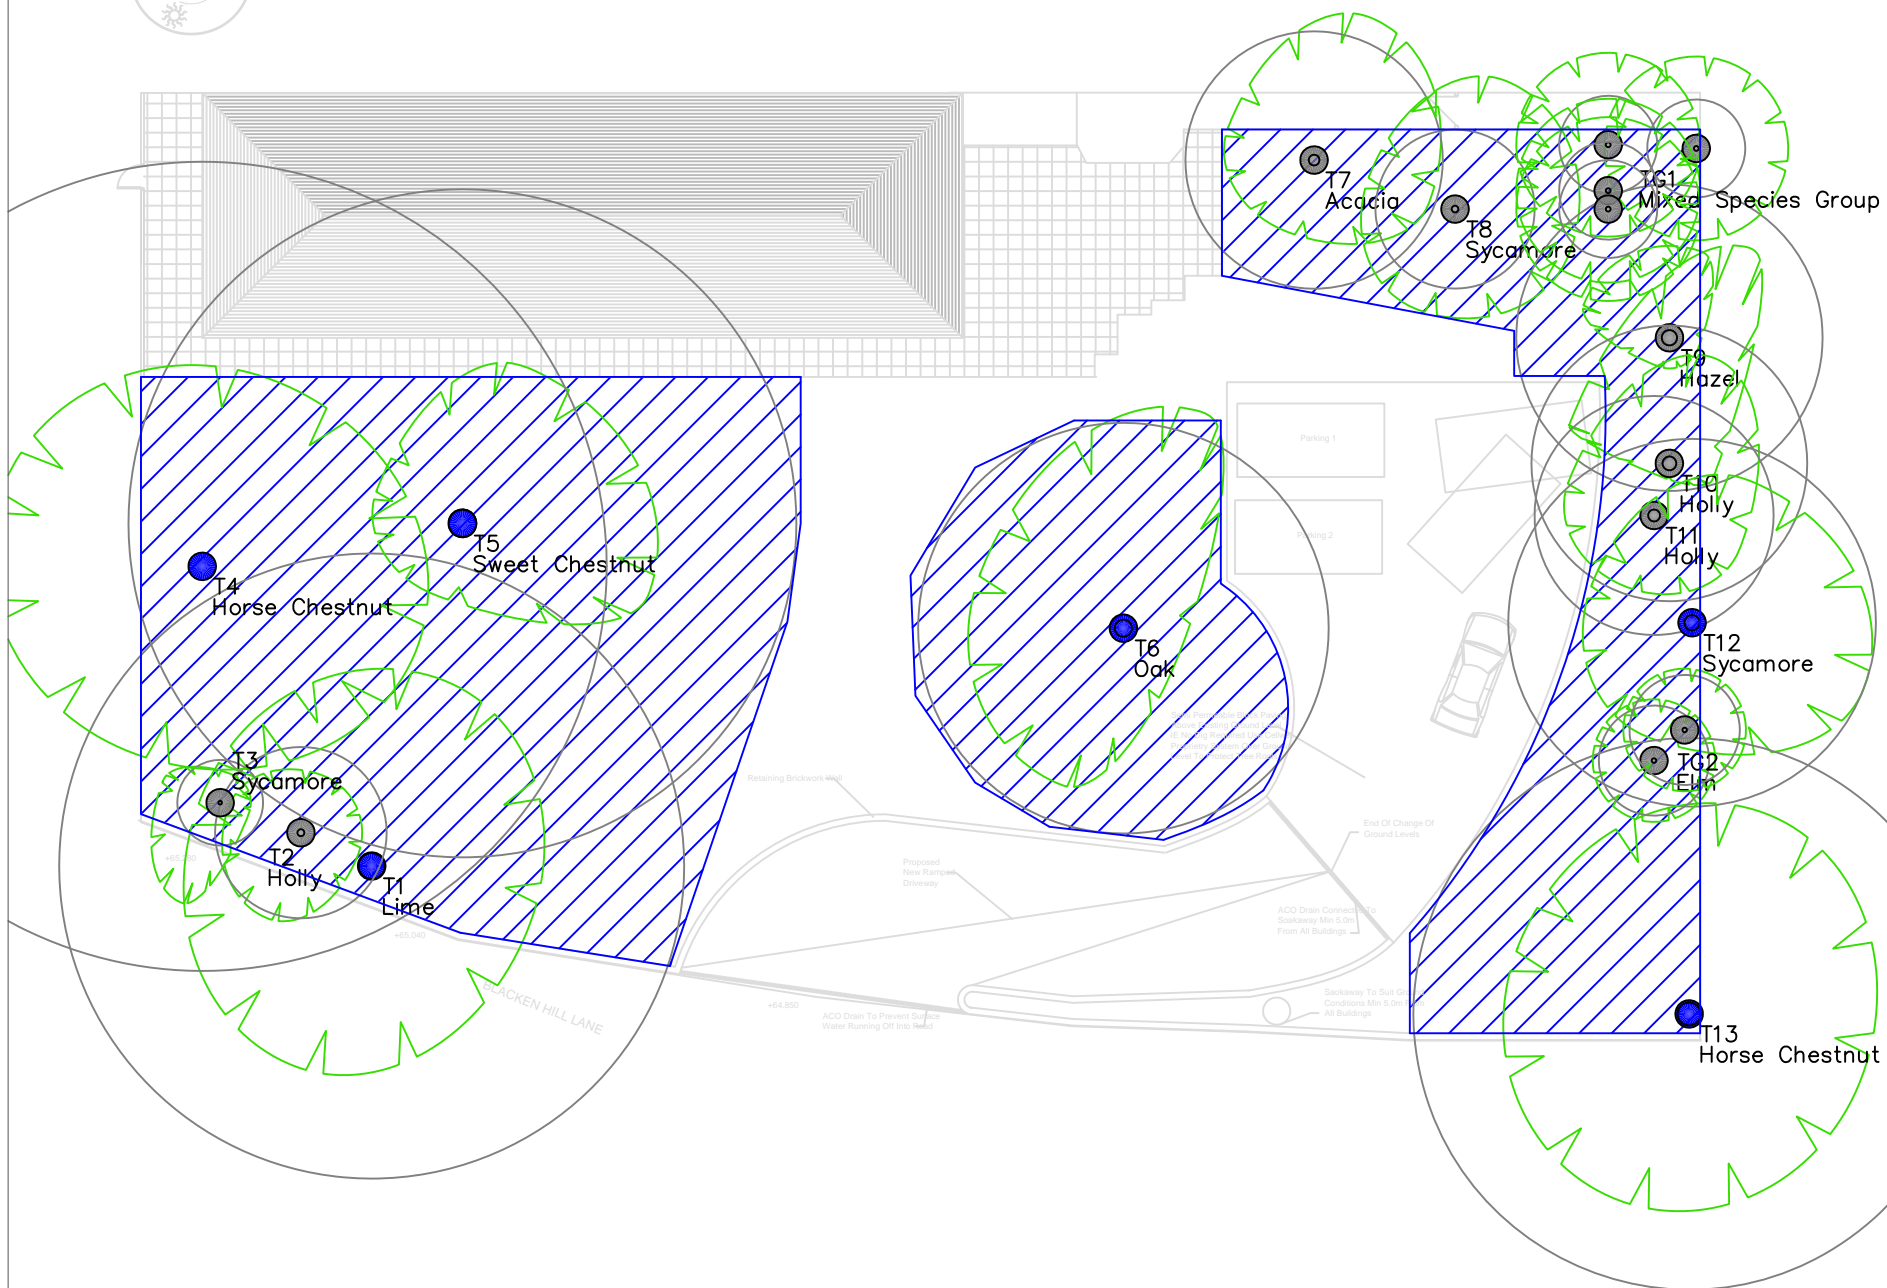
- 3.4 Any potential impact to the retained tree stock will be limited to the construction / installation of the proposed retaining walls and hardstanding in proximity to trees T6, T9, T10, T11, T12 and T13.

- 3.8 The proposed parking and turning area falls slightly within the RPA's of a small number of the retained trees, and although not ideal these intrusions are considered minimal if specialised construction techniques are employed.

- 3.9 To reduce the impact of the proposed hardstanding in this area, we recommend that the area be constructed using No-Dig specification to minimise the impact on the retained trees root systems and to allow for the future growth of roots (Please see Appendix 4 for specification).

4.7 The Tree Protection Fencing will be installed as per the Tree Protection Plan a copy is included in Appendix 2 of this report. The tree protection plan will be agreed with the Local Authority Tree Officer.
