Ref: 1C0104645/190201/L3 Date: 1st February 2019

Additional Geo-Environmental Assessment and Addendum to Remediation Strategy – Beckenham Place Park, Beckenham Hill Road, BR3 1SY

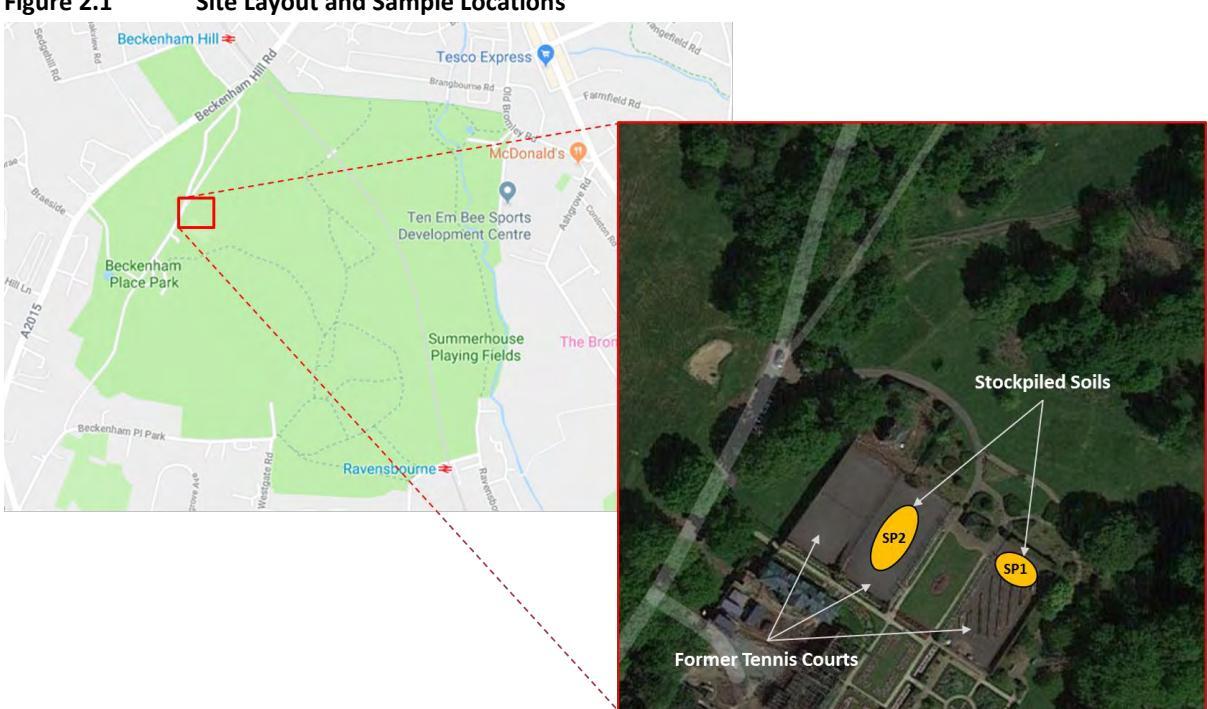
Figure 2.1 Site Layout and Sample Locations

An overview site layout and sample location plan is given as Figure 2.1. A detailed site location plan and a sampling location plan (ref's 1CO104645p7-001 and 1CO104645p7-002 respectively) are presented as Attachment 1.

A total of 3no. soil samples were collected from the stockpiled material (SP1 ES701A, SP2 ES703, SP2 ES706). An additional sample comprising the suspected asbestos cement (SP1 ACM1) was also obtained for identification. Select site photographs are given as Attachment 2.

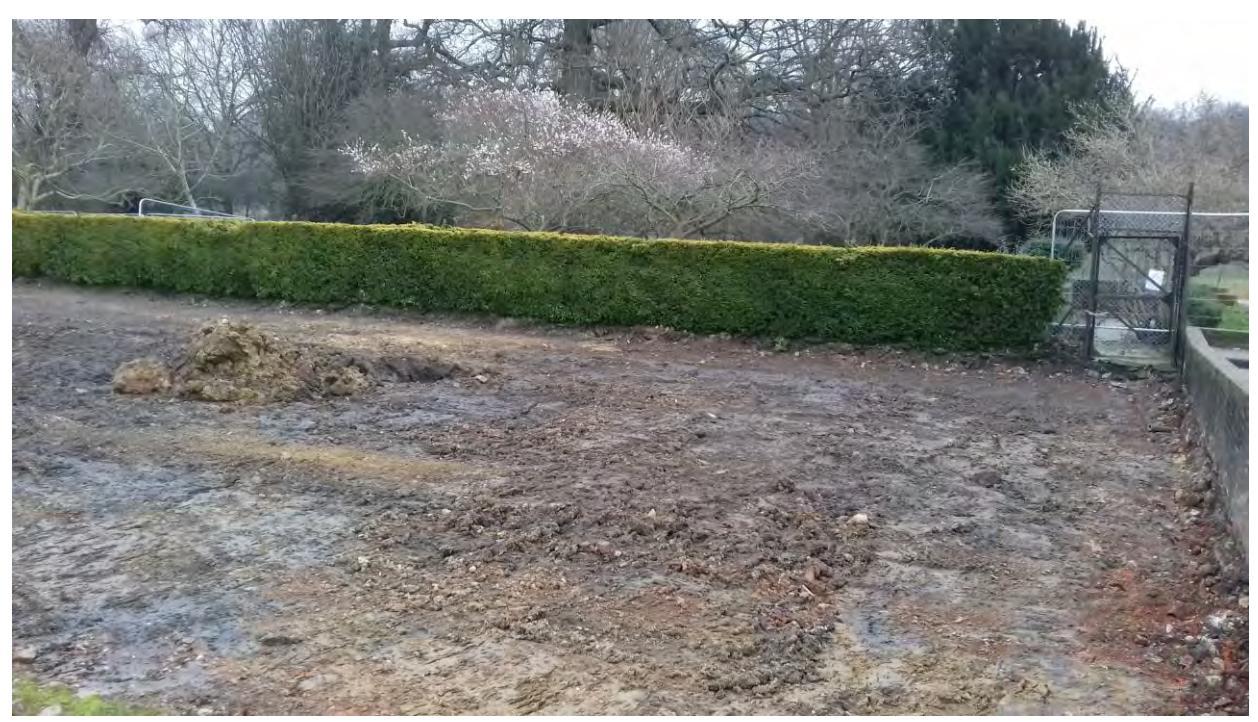
Plate 1: Overview of former tennis court with soils cleared.

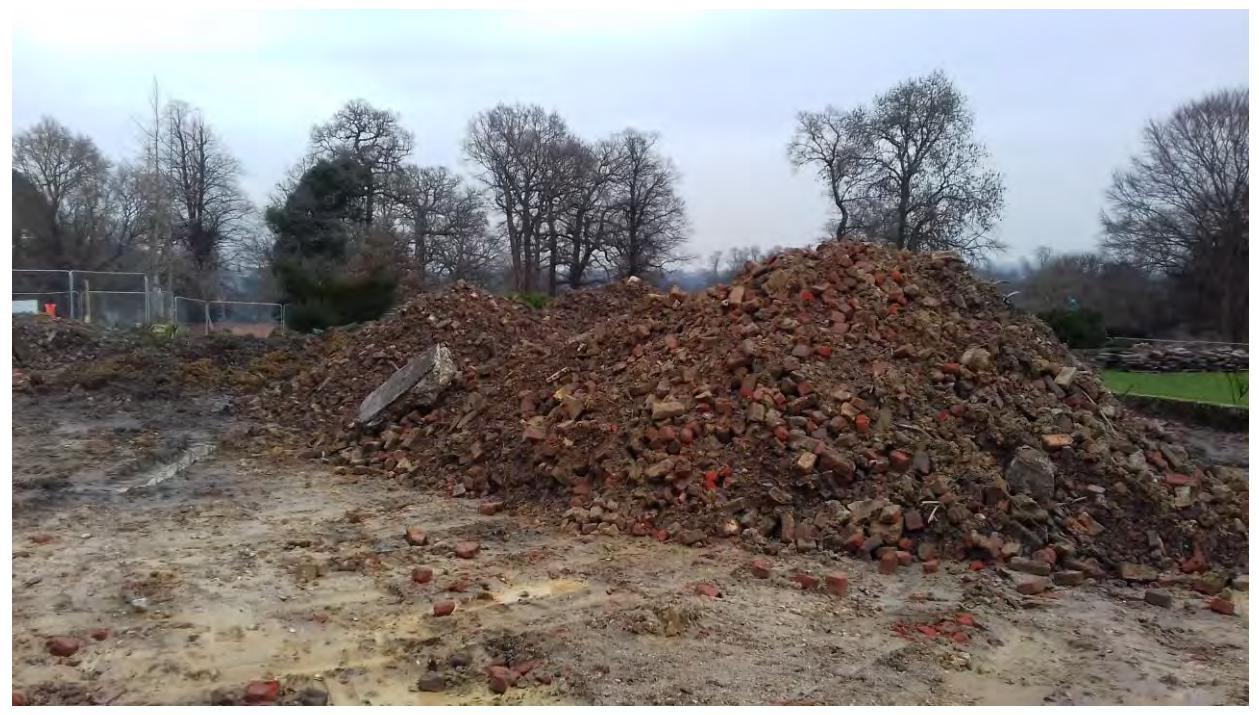
The bulk sample (SP1 ACM1) was confirmed to contain chrysotile asbestos bound in cement. No loose fibres were identified in the sampled stockpiled soils.

The main exposure pathway for asbestos is dust ingestion. Given that only asbestos bound in cement was identified, with no loose fibres detected in the soils, the risk is considered to be reduced. Due to the heterogeneous nature of the stockpiled material it is considered likely that further ACM and or fibres may be present.

In accordance with Environment Agency technical guidance WM3¹, all soils with identifiable pieces of ACM must be considered as hazardous waste without interim remedial measures.

Plate 2: Stockpile of excavated soils where a single fragment of ACM has been identified.

A detailed methodology for remediation of asbestos impacted soils elsewhere at BPP has previously been prepared by REC and approved by the regulatory authority (Remediation Strategy: report ref. 1CO104645/p4/r3, dated October 2018). REC recommends that the same strategy be adopted for the impacted soils on the tennis court site, following hand picking of visible ACM.

- Phased excavation, hand picking of visible ACM and transport of soils to receiving location elsewhere in Beckenham Place Park as part of current MMP which will need updating accordingly.;
- REC understands that the previous designated receiving location (B1 on drawing 1CO104645p7-003 in Attachment 1) is to be used for soils excavated from the tennis court site.
- Update to the existing MMP and encapsulation soils once screened; and
- Independent verification of the works and production of a validation report.
