SITE 12: BECKENHAM PLACE PARK

PROPOSED MATERIALS

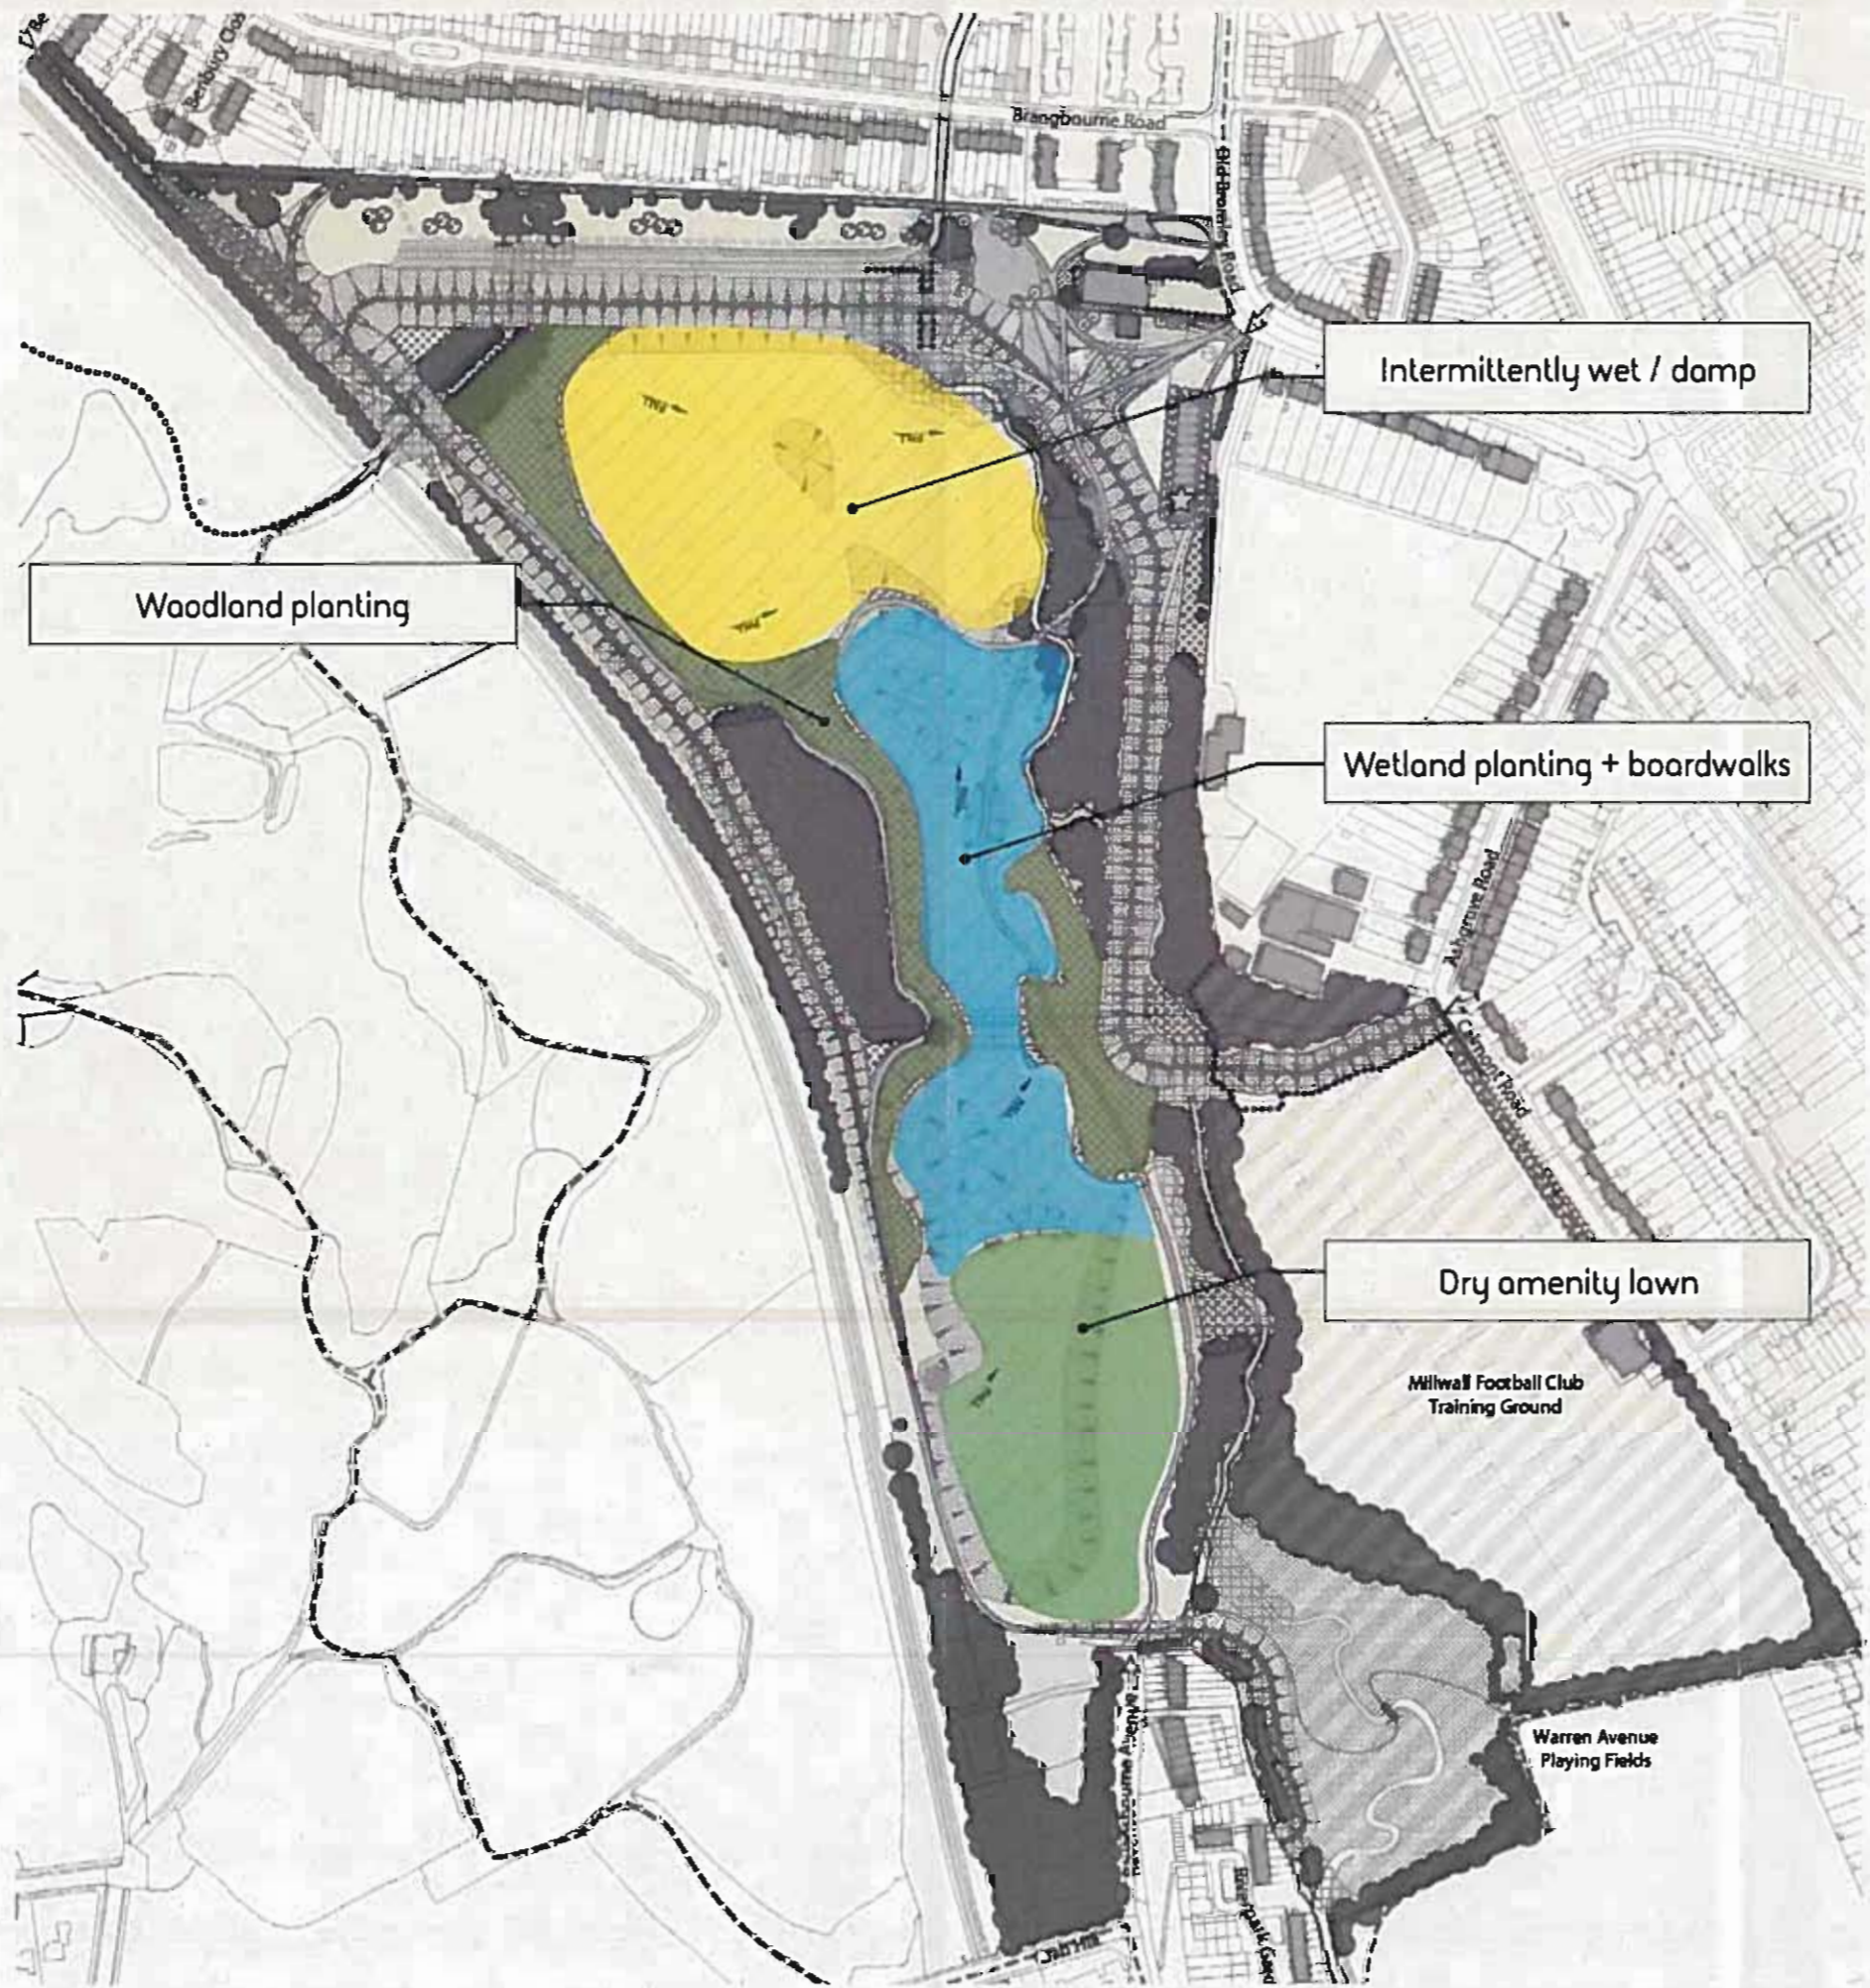
Woodland planting

Intermittently wet / damp

Wetland planting + boardwalks

Dry amenity lawn

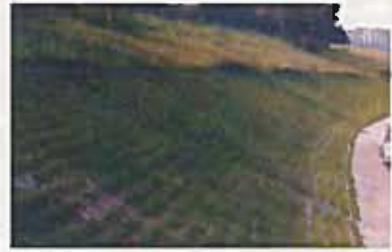
Grasscrete slope

Grasscrete embankment

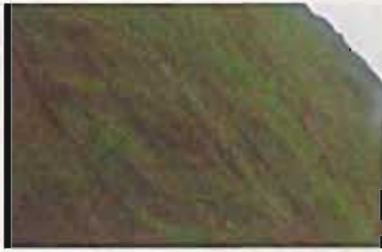
Geotextile mesh reinforced slope

Geotextile bank reinforcement mesh

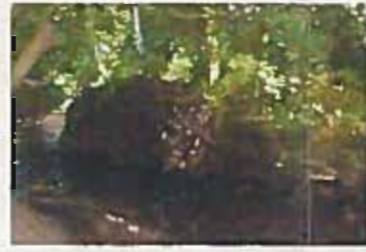
Reinstated tree roots + gravel bank deposits for habitat creation

Reinstated tree root systems for habitat creation

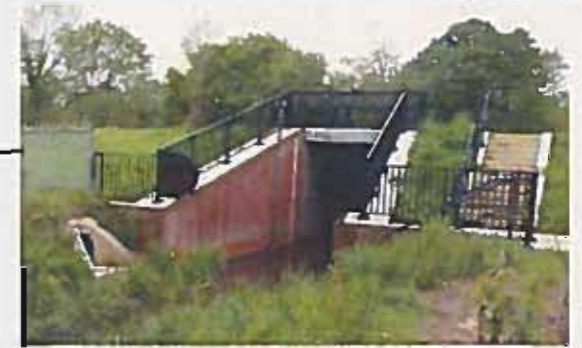
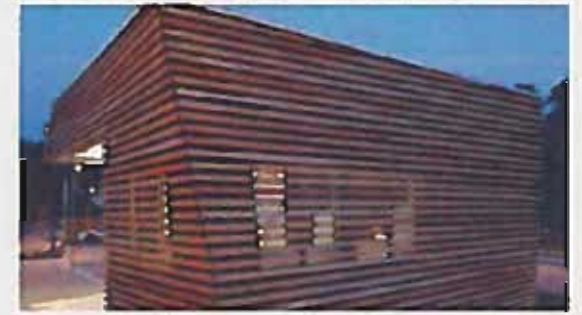
Control structure elements

Brushed concrete channel with dropped central section

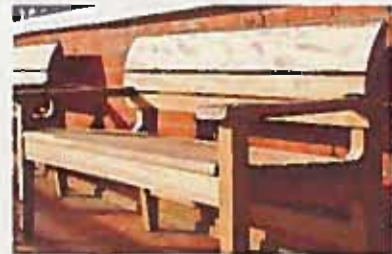
Bespoke timber bench to match HLF scheme

Bench - Bespoke timber to match HLF scheme

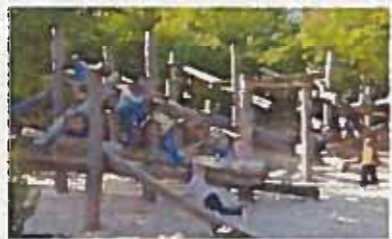
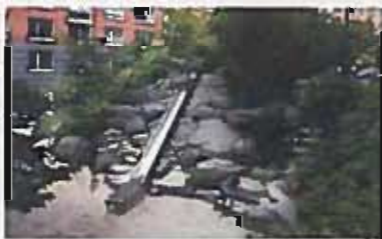
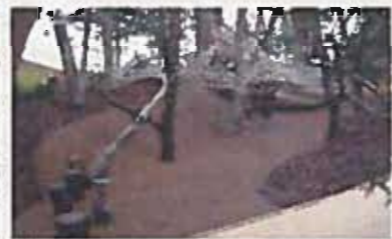
Adventure play equipment incorporated into landforms

Adventure play equipment: 10 no. timber play elements

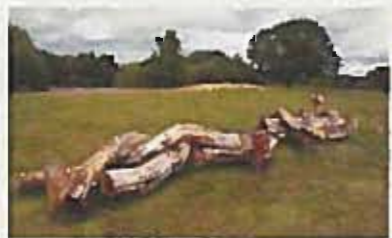
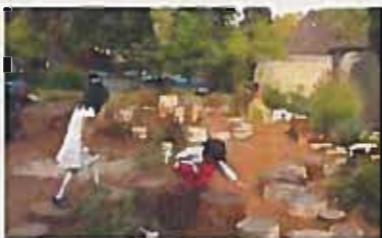
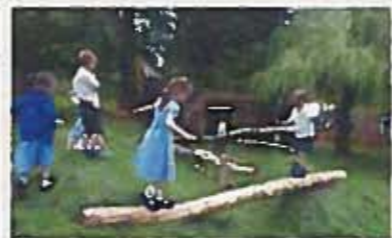
Informal natural play elements

Informal adventure play: tree stumps, trunks, logs, etc.

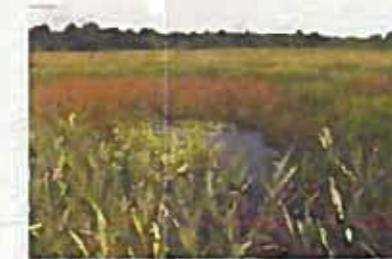
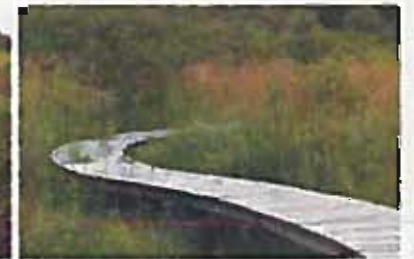
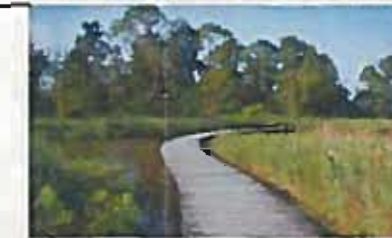
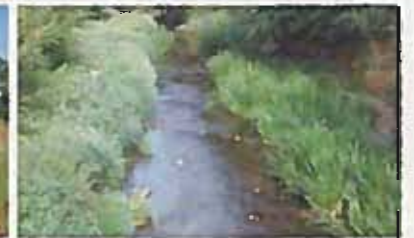
Stog beetle habitat: brush piles

Wetland grasses with timber boardwalk

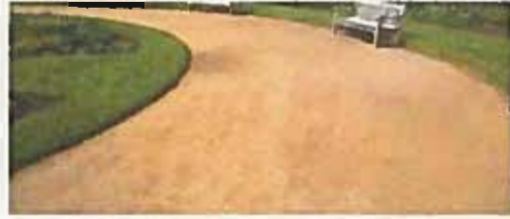
Self-binding Breedon gravel path

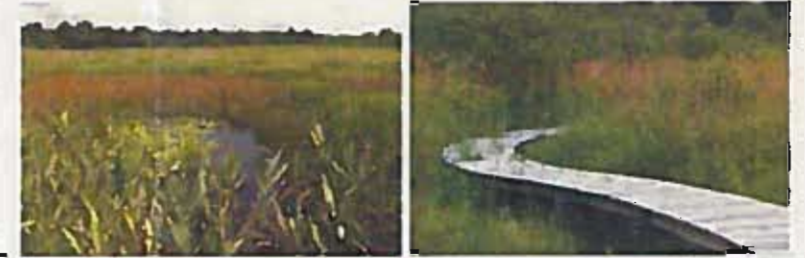
Wetland grasses with timber boardwalk

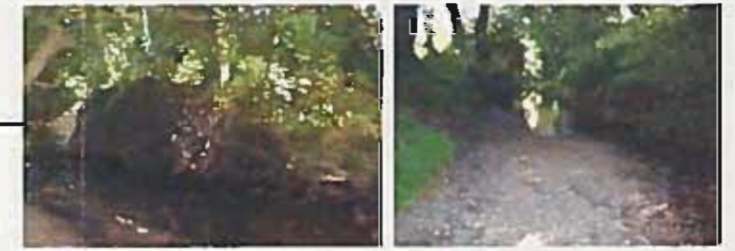
Reinstated tree roots + gravel bank deposits for habitat creation

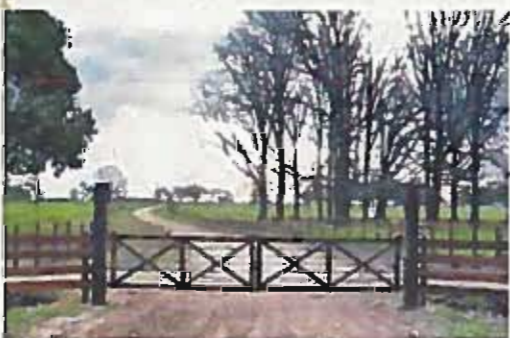
Timber entrance gates + fencing

Entrance gates and fencing - timber
