Beckenham Place Park Stable Block and Courtyard

Proposed new lighting installation Heritage statement

Proposed new lighting installation Design and Access Statement

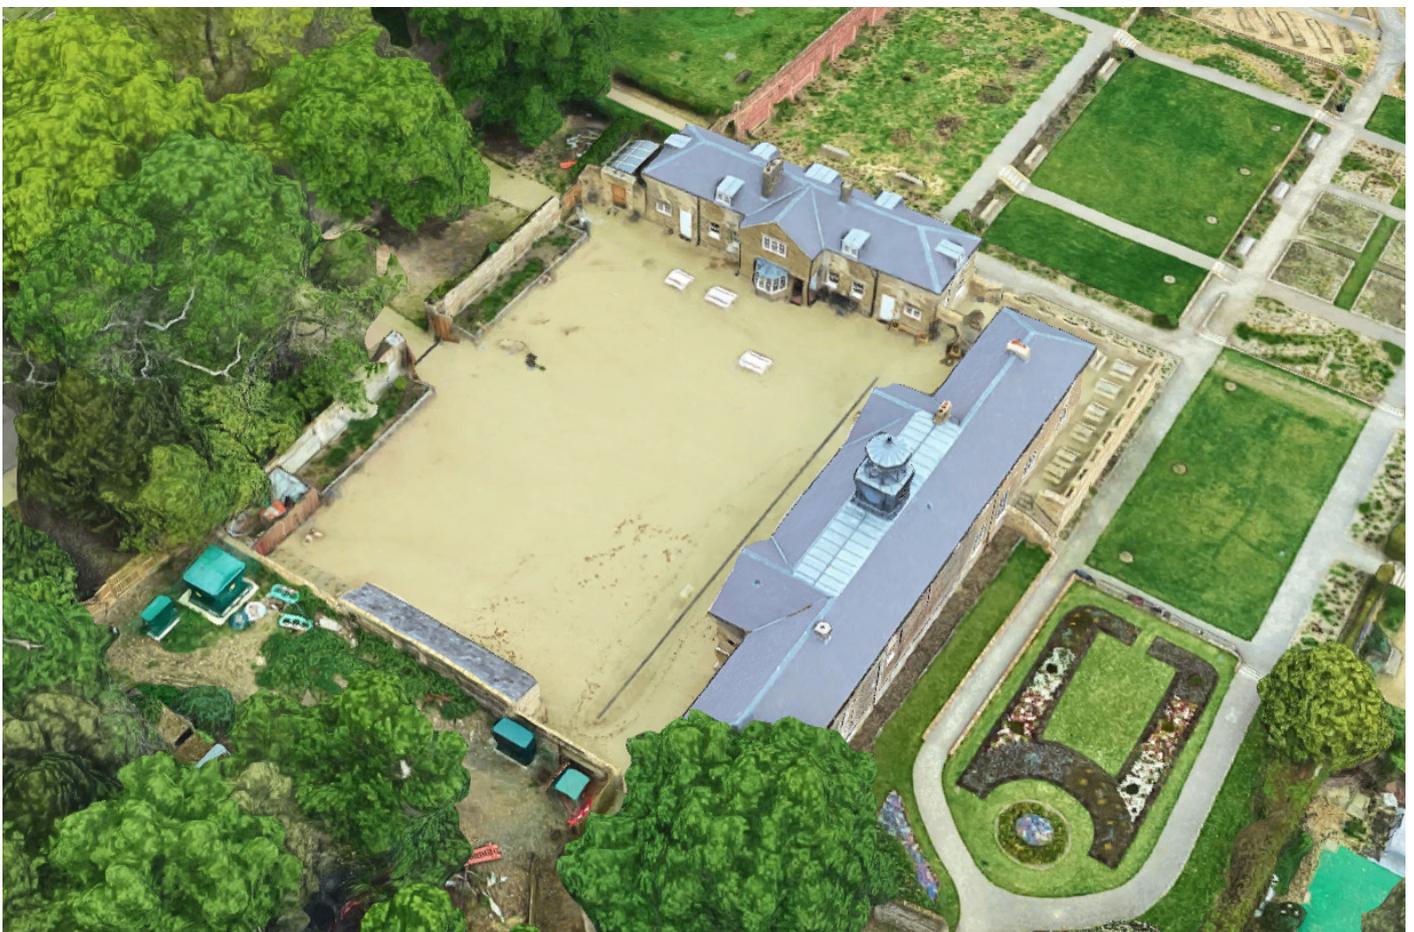
Aerial view as existing of stable block, with north to the top.

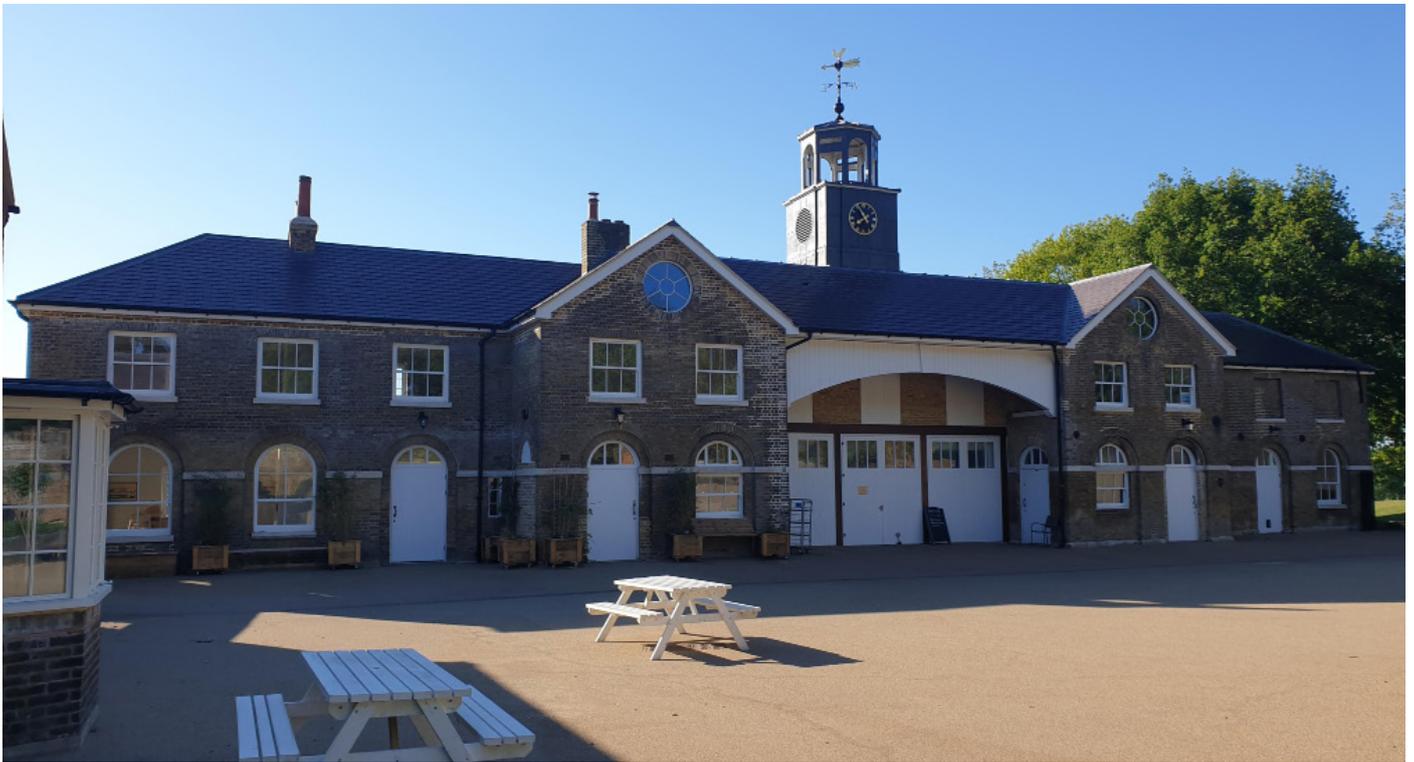
Main elevation of the stable block facing into the courtyard

The building is two storeys, and thirteen bays in elevation facing northwest into the courtyard, its most prominent elevation. The roof is hipped at either end with protruding gables either side of the central three bays. The central area between the bays has a protruding roofline with a crown roof fronted by a timber fascia, providing a covered area in front of the doors below. The walls of the stable block are stock bricks in Flemish Bond

The main plan of the building has one long ridge line with two, two bay protruding gable ends flanking the three central bays.

The central three bays consist of three barn doors to the ground floor and three timber doors to the first floor. The ground

floor barn doors were of a size that only a timber post was positional between. The remainder of the ground floor window and door openings have semi circular stepped brick arched heads and a connecting horizontal rendered band tying into the springing point of the arches.

The first floor has a series of square window openings, matching the ground floor in elevation, but simpler in detail with rubbed flat brick arches. The openings to the southern end of the elevation were constructed as blind openings. Circular openings are positioned beneath each protruding gable end.

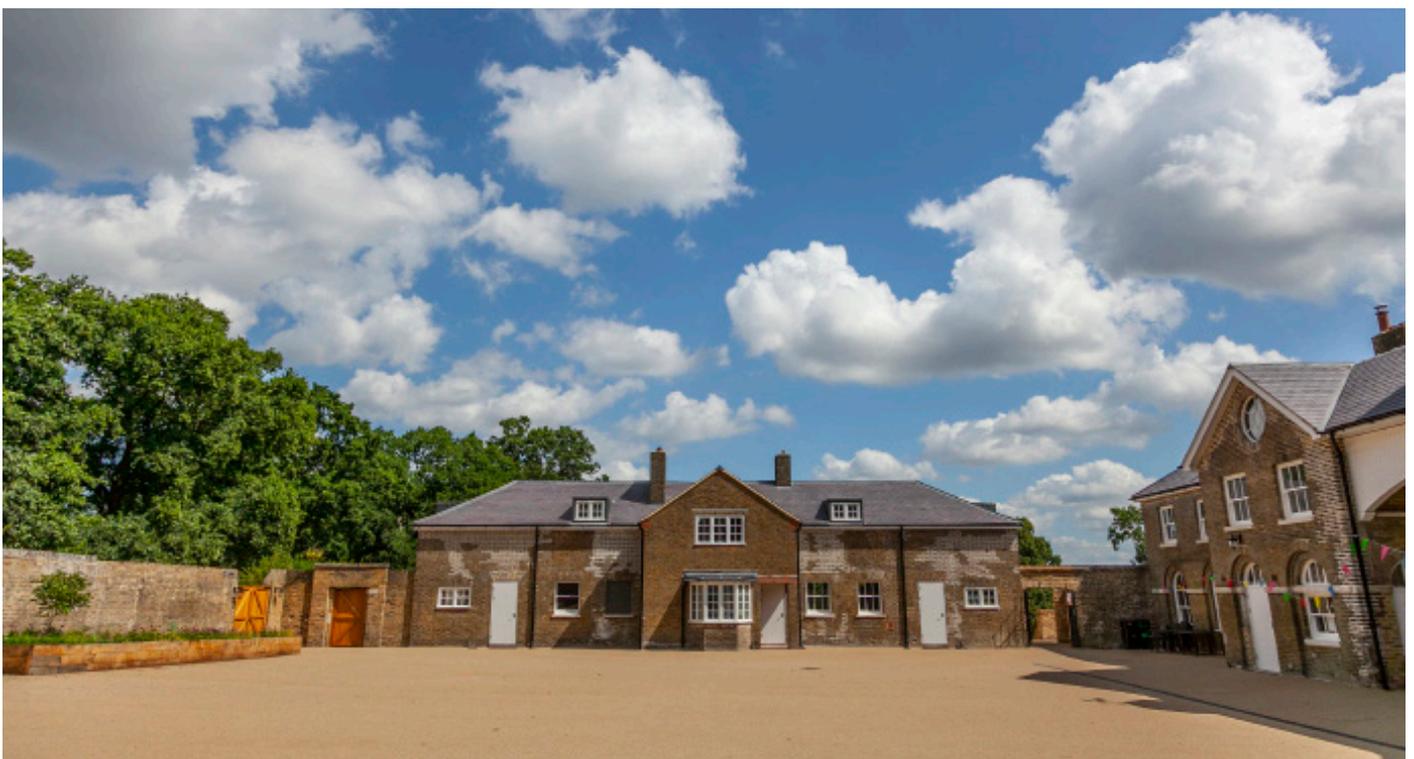
Northern elevation of the stable courtyard with the main two storey block to the right, the original cottages to the centre and the courtyard west wall to the left with raised planting beds.

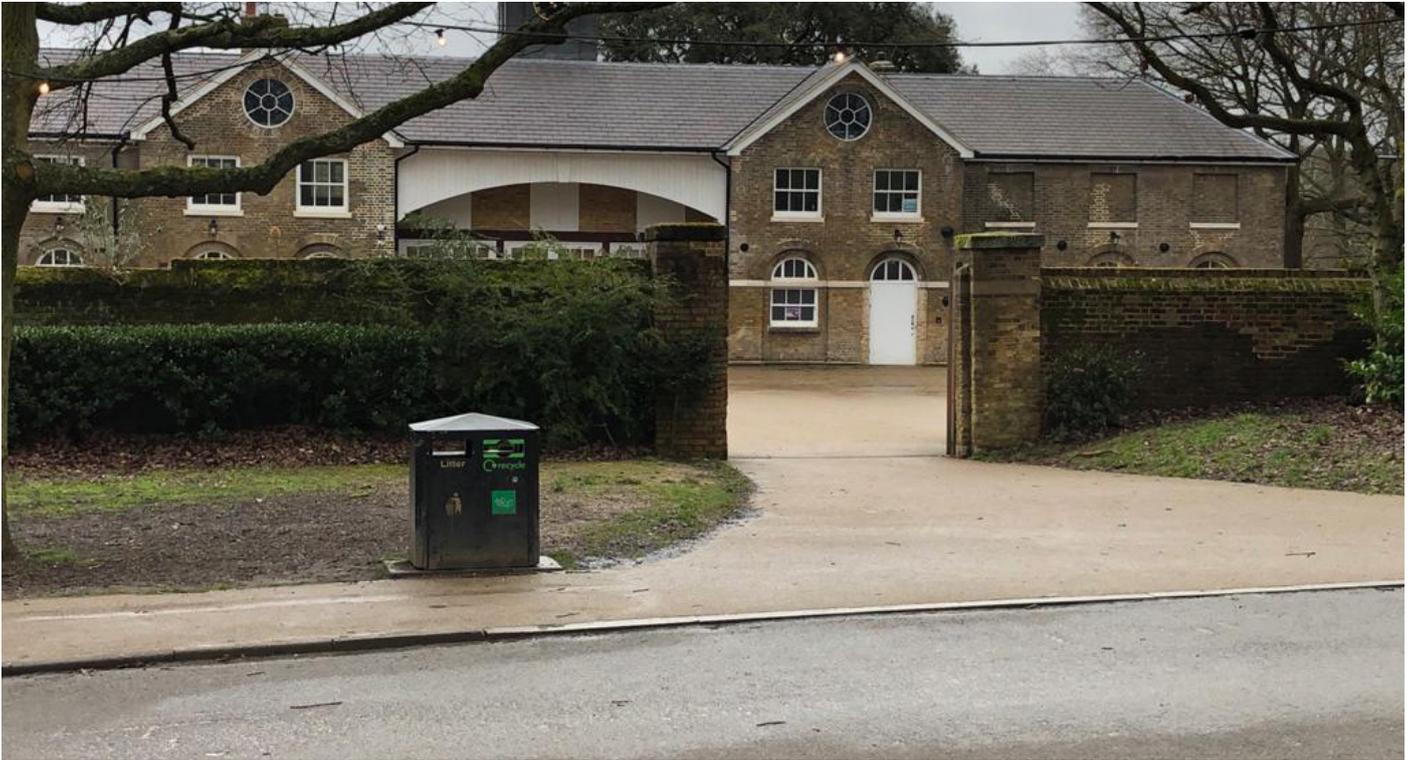
External appearance of courtyard walls. Proposed post to left hand section

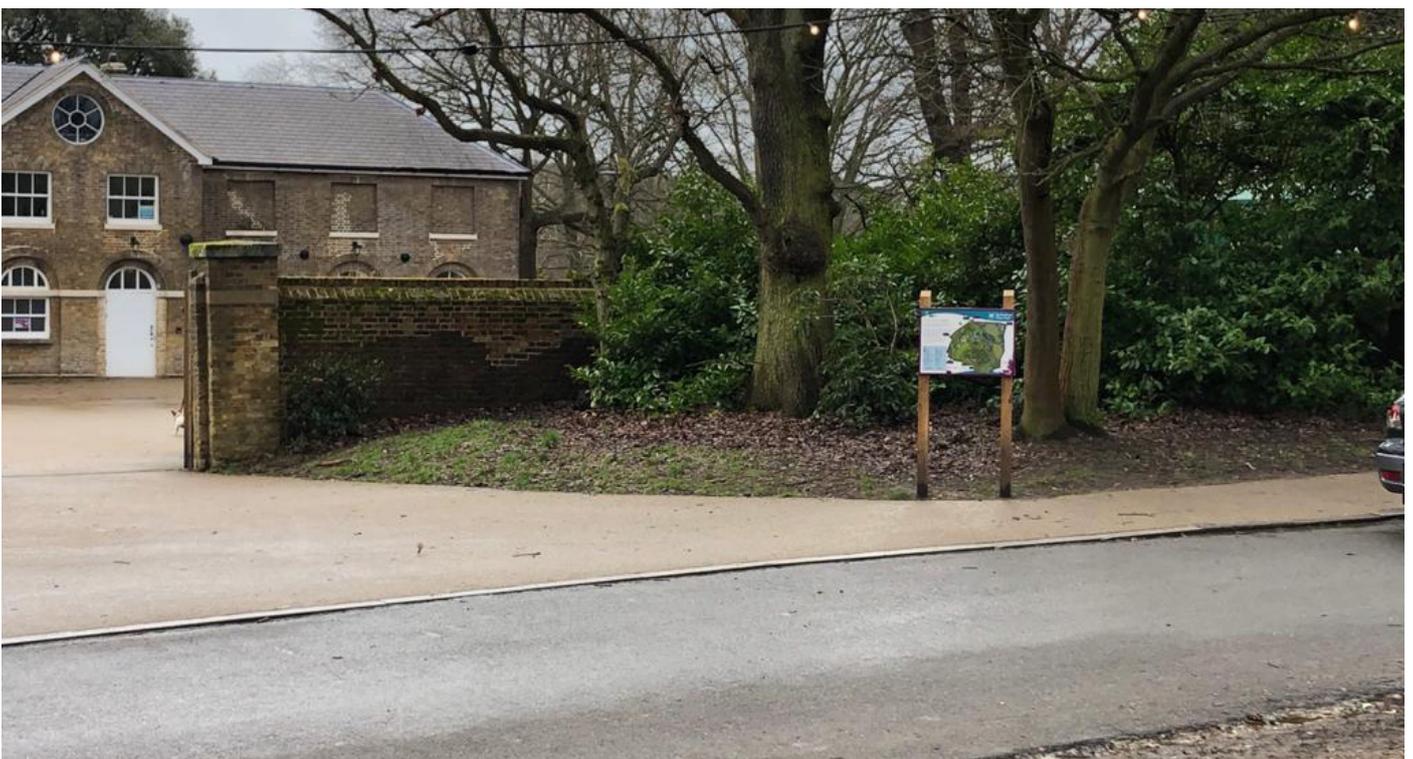
External appearance of courtyard walls. Proposed post to right hand section behind the trees

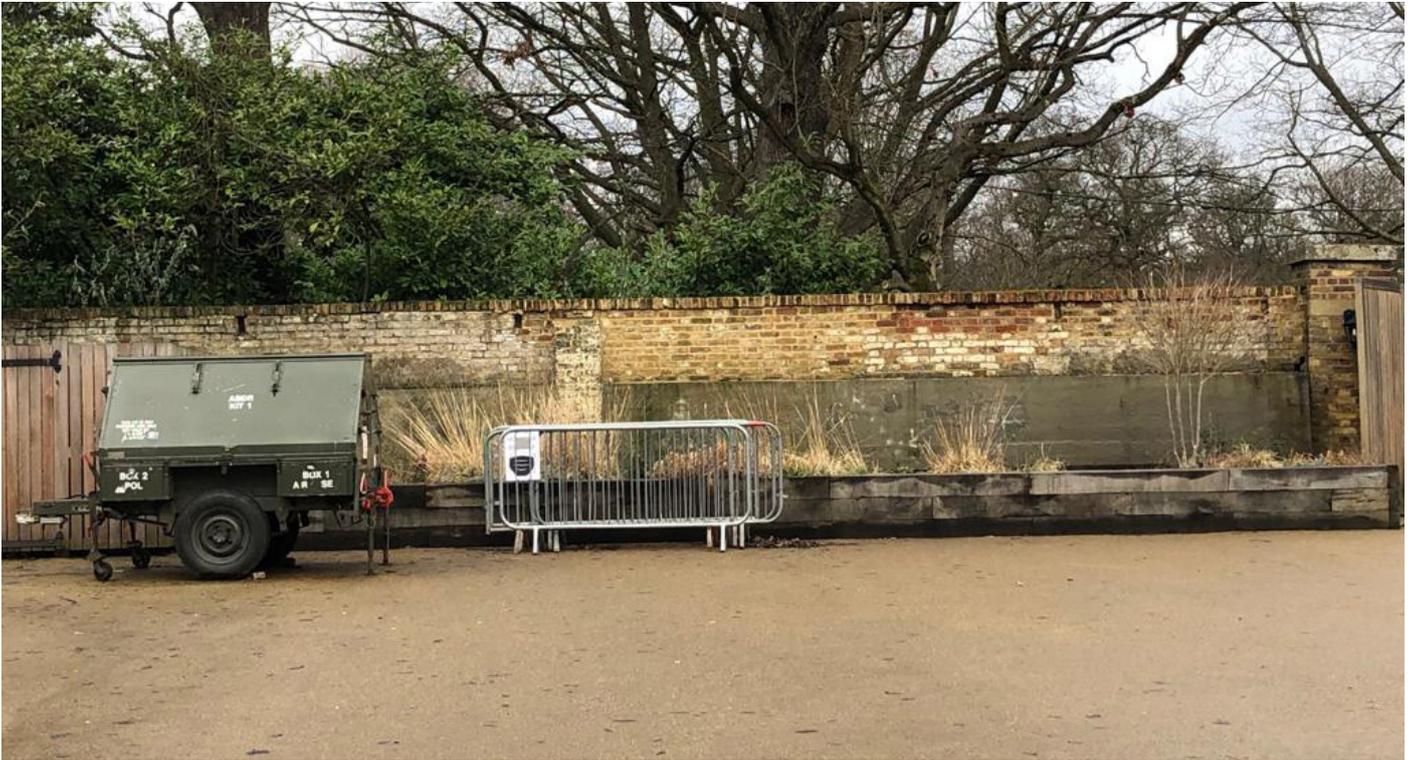
Internal appearance of courtyard walls. Proposed post to middle of wall

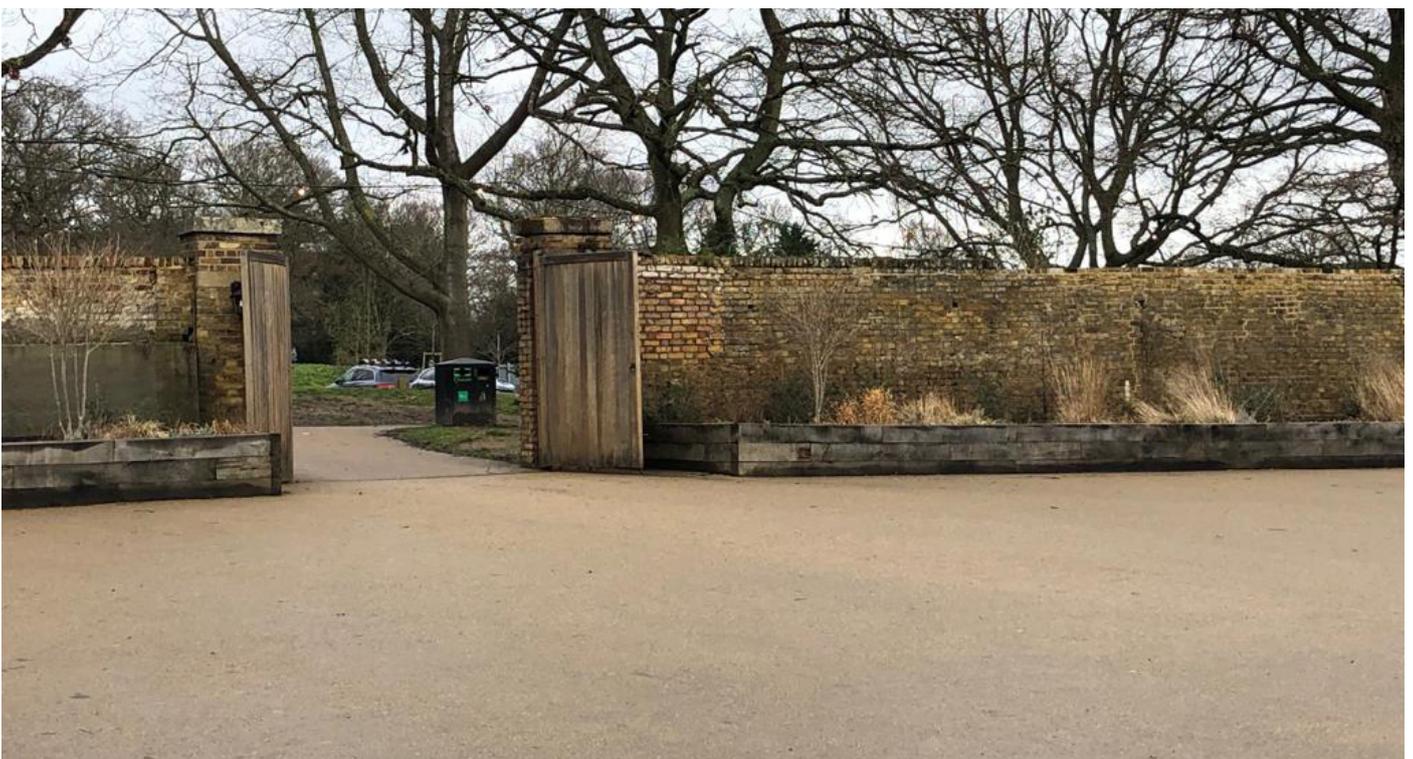
Internal appearance of courtyard walls. Proposed post to middle of right hand wall
